Manhole Inspection Summary

Manhole # S65M__011MH

Insp Date: **5/14/08 11:00 AM**

Location Address: **1100 Broening Hwy.**

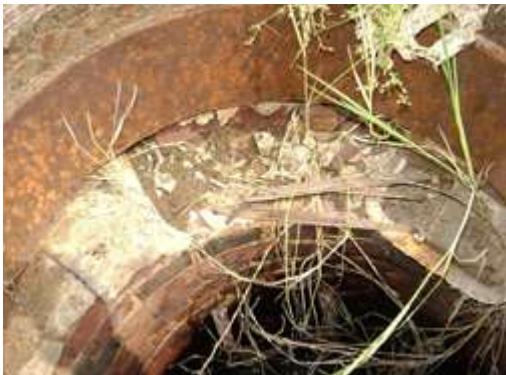
Defect 1

Offset: **8** (in.)

Condition: ☐ Sound ☒ **Cracked** ☐ Leaks

frame offset

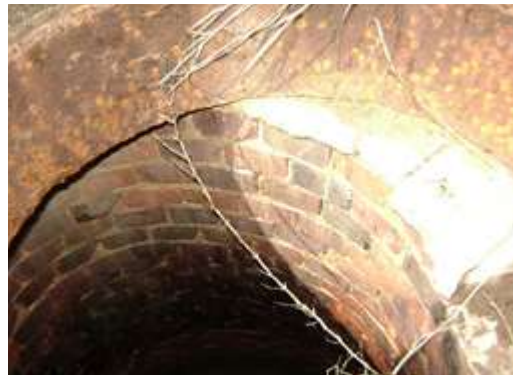
Defect 2

grass roots

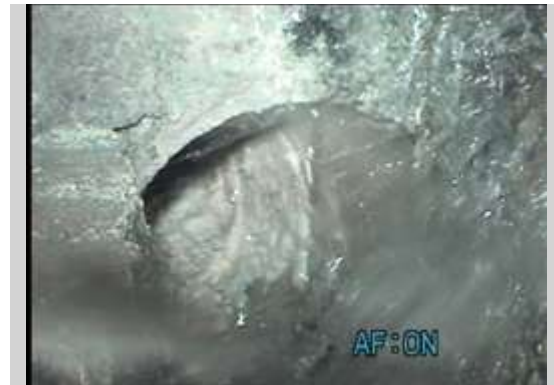
Drop In @ 3 O'Clock

Comments **INCOMING DROP CONNECTION CLOGGED.**

Drop: **Outside** Rod and Bar
Angled: **Yes** Reading: **7.58** (ft.)
Inv Depth: **8.58** (ft.)
Drop Condition: **Clogged**

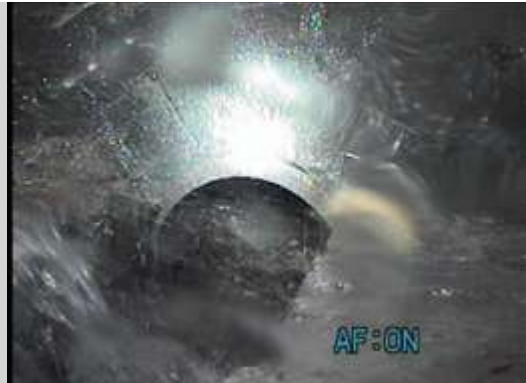
6 O'Clock Inflow

Deposits: ☐ None ☐ Mud ☒ **Sludge** ☒ **Debris** ☐ Grease

Silt Depth: **1.5** (in.) Deposits Extent: **Light**
